# Floor Coating Failure

Gel found beneath a blistered coating may not always be NSAR.

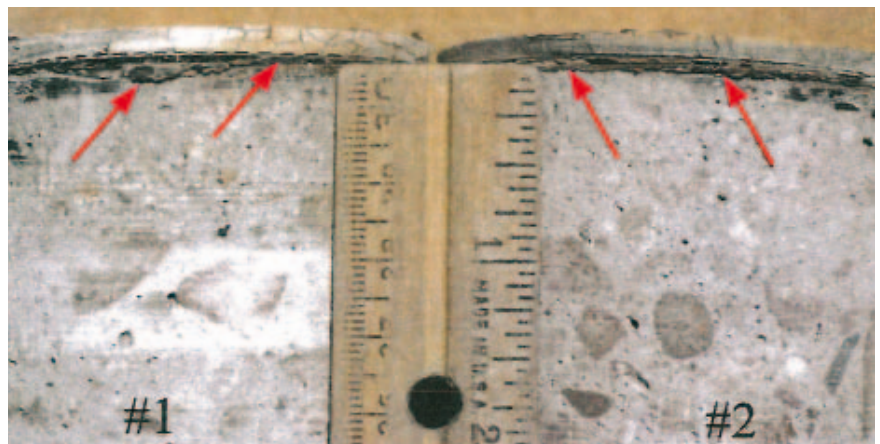
Figure 1.

Both core samples (side view) from the failed floor had near-surface parallel cracks. PHOTOS: RJ LEE GROUP

Core samples were taken and found to have fine cracks parallel to the surface (Fig. 1, pg 33). The surface was irregular with concave upward micro-cracks near the surface of the cores, which is characteristic of a shot-blasted surface.

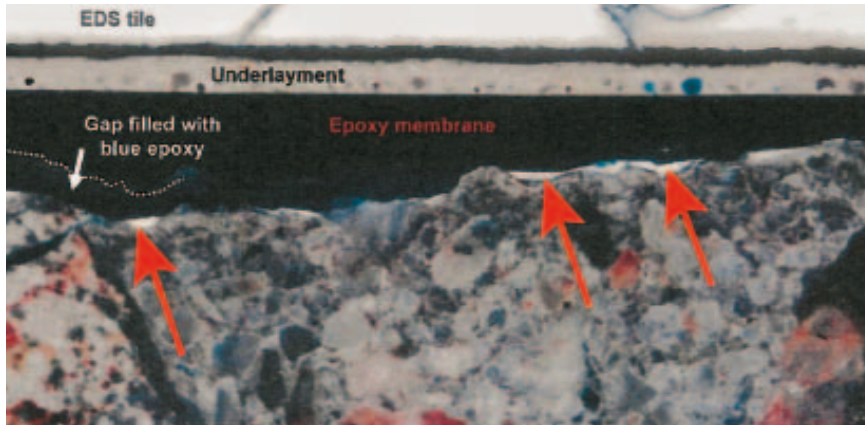
**Figure 2.**

The layers of the floor system with arrows pointing to the white areas (silica gels) on the surface of the concrete.

A micrograph of a core sample cross-section (Fig. 2) shows the layered components of the floor system: tile, underlayment, epoxy, silicate gel, and shot-blasted concrete surface. Our initial conclusion was that the near surface cracks were a result of distress from NSAR gel, instead of from shot-blasting and poor surface preparation. Lithium silicate, applied to the shot-blasted surface, was assumed to have been applied to arrest ASR in the near-surface concrete. This lithium reaction is similar to those of other alkalis. Unlike in ASR, however, lithium silicate gel does not absorb excess moisture, thereby preventing harmful gel expansion, stress,

The presence of the applied lithium silicate is evident along the undulating surface. Note the similarity in gel location and appearance in the laboratory sample and field sample (Fig. 2, pg 34).

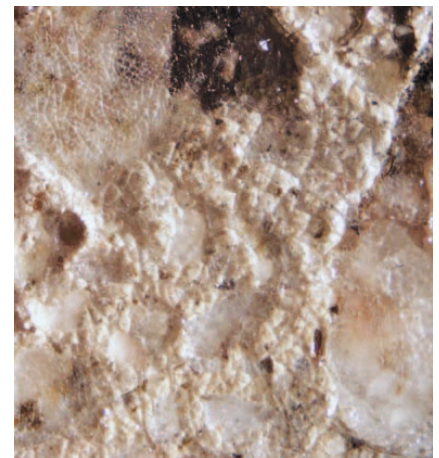
**Figure 3.**

The surface of the lab sample shows lithium silicate applied to the sand-blasted concrete surface.

The gel in the failed floor appeared identical to ASR but could be lithium gel instead. To address this, we did some work in the lab. We used a 3-inch diameter concrete core with a finished surface and sand-blasted it to create a concrete surface without any pre-existing laitance or contaminants. We then applied a commercial lithium silicate solution uniformly on the sand-blasted concrete surface and allowed it to dry overnight. Figure 3 (pg 34) shows the irregular surface from shot-blasting and the lithium silicate coating.

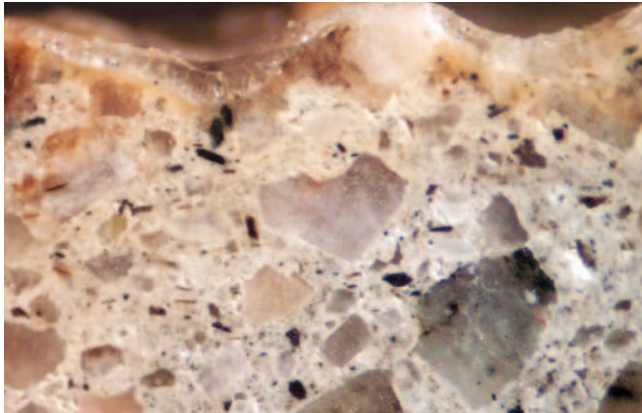
**Figure 4.**

This cross section, left, of the lab sample shows lithium silicate along the sand-blasted concrete surface. Note the gel in the depressions created by sand blasting. This thin-section photomicrograph shows lithium silicate gel on the undulating, sand-blasted concrete surface.

Next, we cut a cross-section to study the penetration of the solution into the concrete and to determine if it occupied pre-existing defects and micro-cracks in the concrete. A thin cross-section was prepared from the top portion of the core and was analyzed using optical and scanning electron microscopy. Figures 4 and 5 show photographs from the optical microscopy examination.

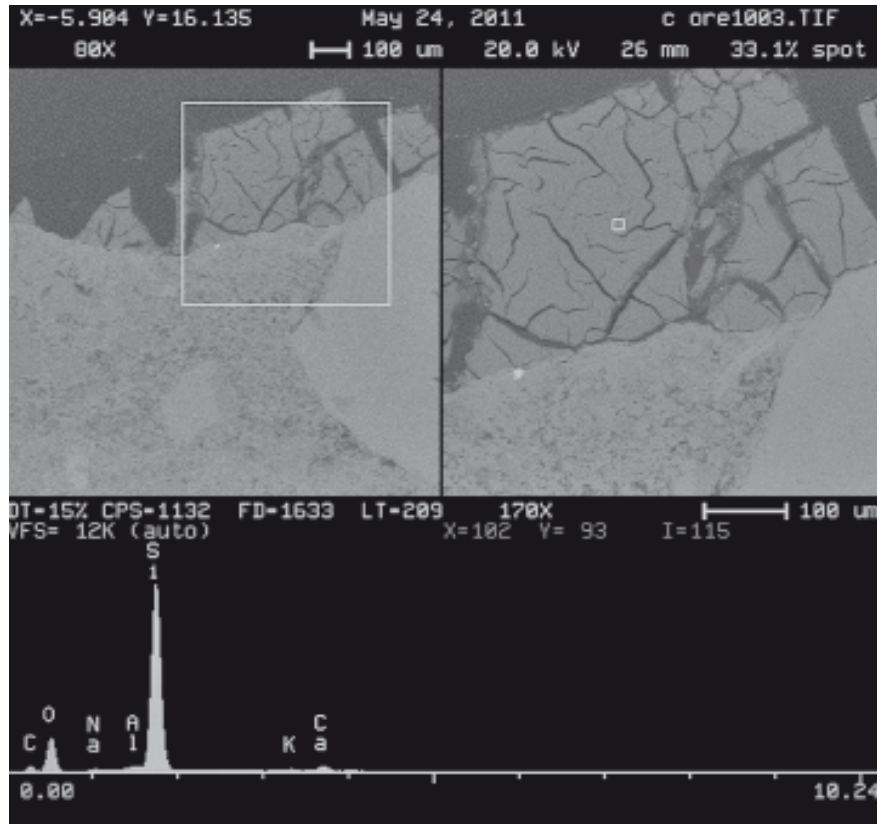
Figure 6.

At the top are scanning electron microscope images of a cross-section of the laboratory sample. At the bottom is the electron dispersive spectroscopy spectrum showing the elemental composition of the lithium silicate gel along the surface.

To complete the study we used the scanning electron microscope on a

cross-section of the laboratory sample to show that the hardened gel has a similar appearance and the same optical properties as ASR gels. We then ran EDS to determine which elements were present in the gel. Note that there is no lithium peak since lithium is not detectable using EDS. Sodium and potassium, however, which can be detected using EDS, are present at only extremely low levels. Sodium and potassium are elements that are associated with ASR and NSAR. So knowing that lithium is not detectable using EDS, and that lithium silicate was applied to the surface, we conclude that the gel is lithium silicate and not NSAR gel.
